# An Alternative Approach to Replacement of an Avulsed Central Incisor

**Abstract:** This report describes the case of a young girl who underwent orthodontic and restorative treatment following the ankylosis of an UR1. The case sets out an alternative treatment to prosthetic replacement following the loss of an incisor tooth.

**Dent Update 2018; 45: 215–225**

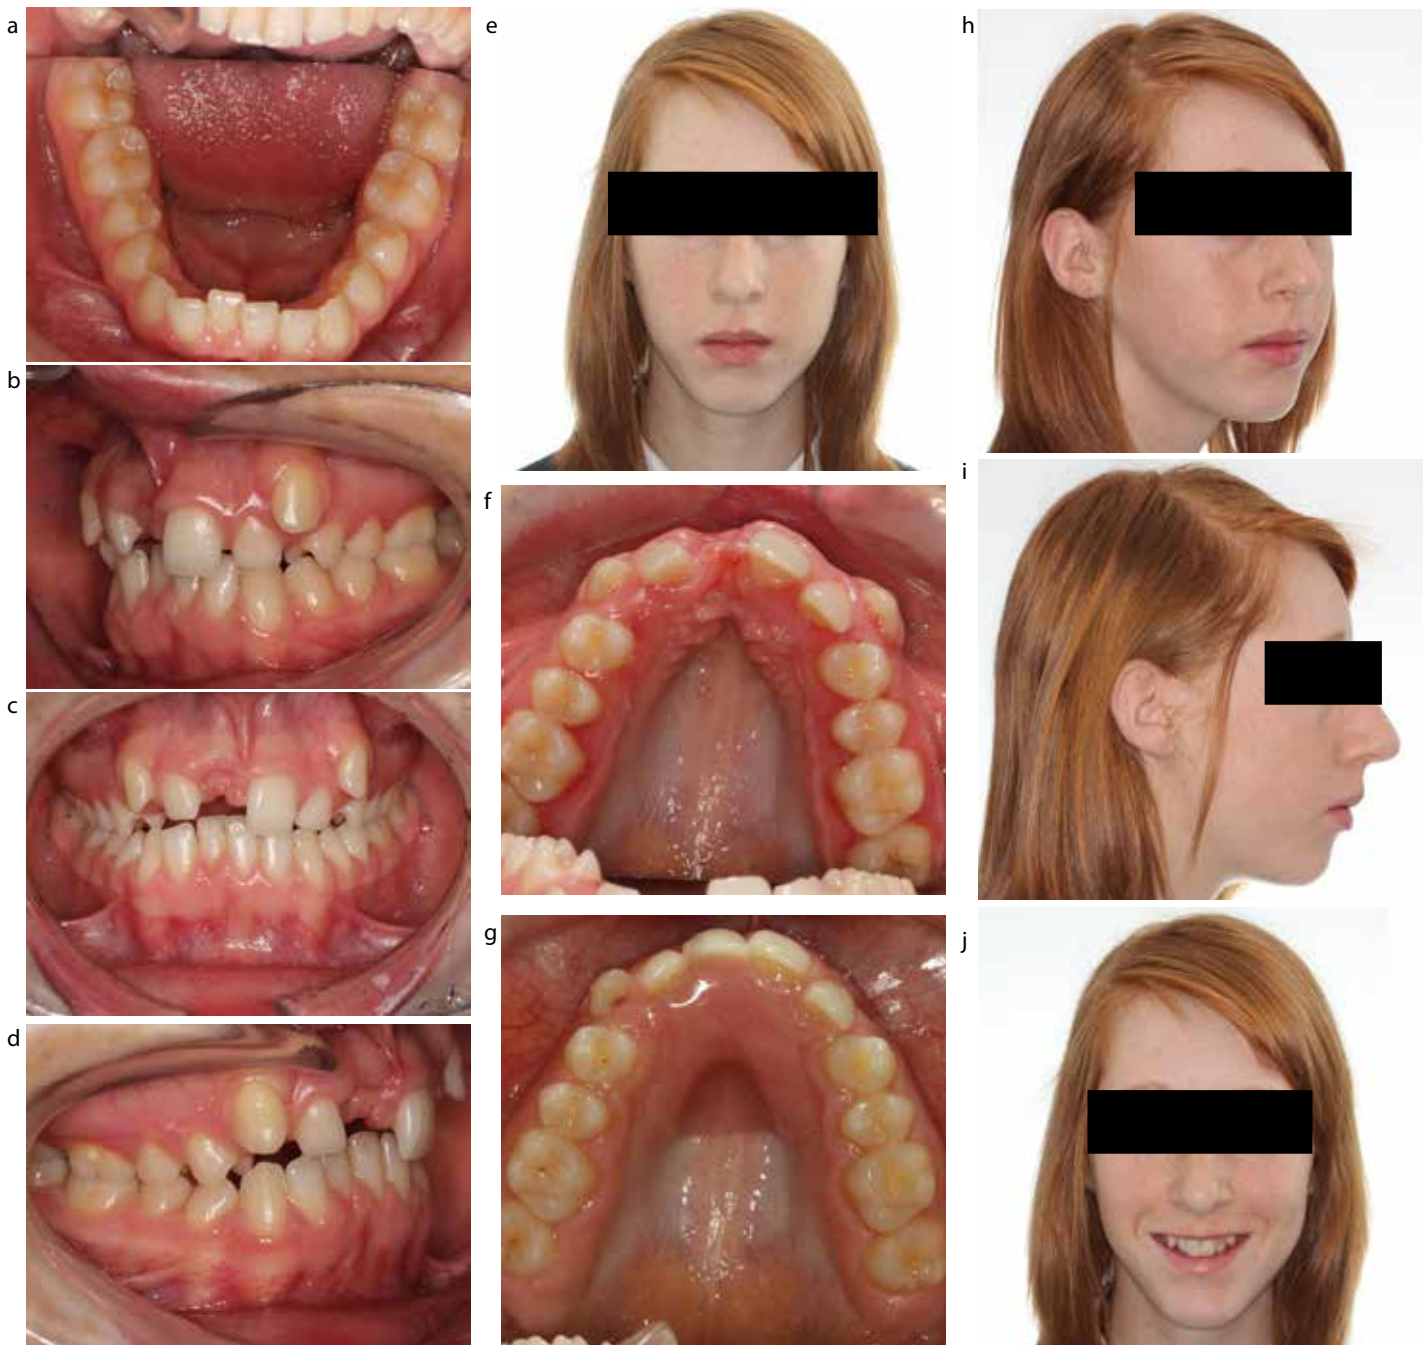
**Figure 1. (a-j)** 6/6/13. Initial intra-oral and extra-oral views, including partial denture.

lower incisors, a moderate curve of spee and a lower centreline shift to the right by 3 mm. The lips were competent at rest, with full incisor show on smiling. Buccal segments were ½ Class II on the left-hand side and ¾ Class II molar on the right-hand side. The IOTN was 4d, due to the displaced canine (Figures 1 and 2).

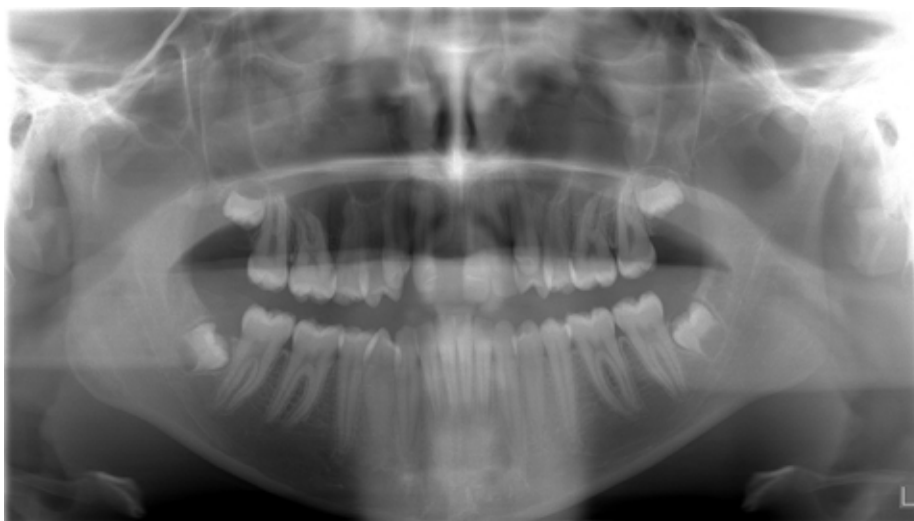
Figure 2. OPT taken 16/10/12.

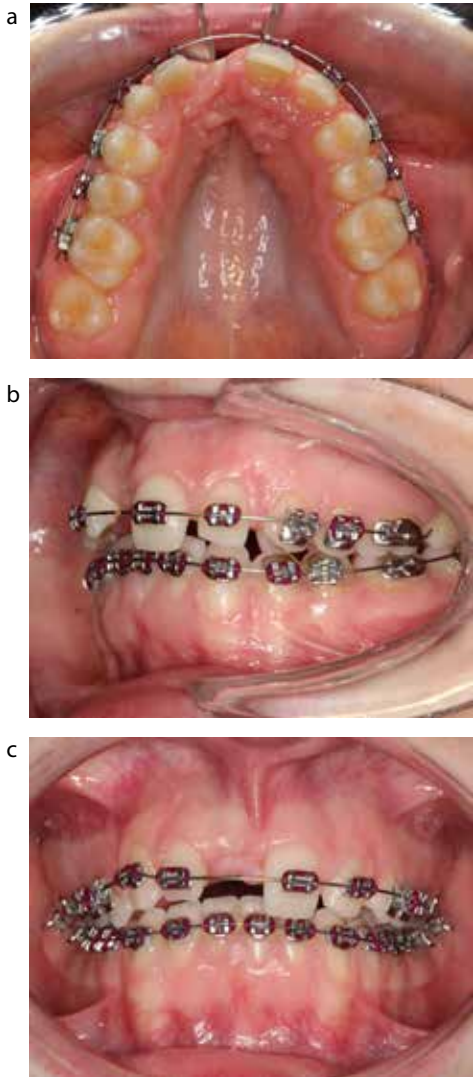
**Figure 3. (a-e) 28/11/13. Bonding of the Lower 7s, 0.016" NiTi RP and invert UR3.**

Treatment started in June 2013 and began with initial alignment with 0.016" nickel titanium archwires. The UR3 was inverted to change the torque from -7 to +7, to reduce the prominence of the canine root labially (Figure 3).

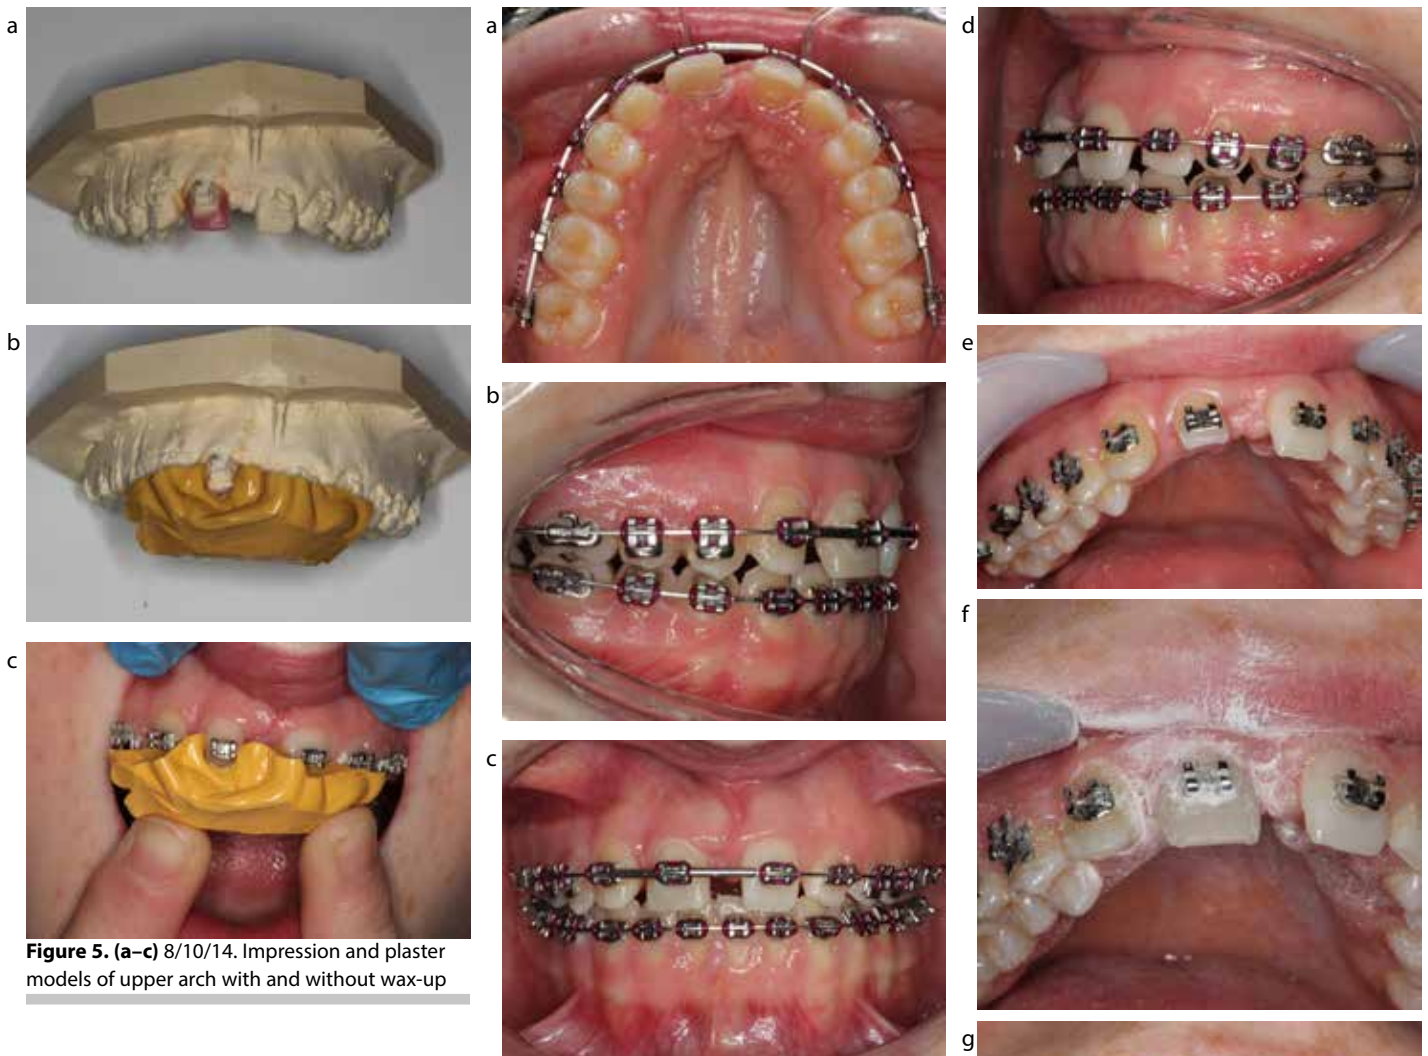
**Figure 5. (a-c)** 8/10/14. Impression and plaster models of upper arch with and without wax-up

space had been created mesially and distally around the tooth, an alginate impression was taken of the upper arch with the archwires removed. The wire was replaced and the position of the UR2 was held exactly by placing stainless steel tubing, either side of the tooth, on the archwire. This impression was used to provide a kesling set-up and build the UR2 to a relative size to the UL1. Once the clinician was happy with the mock up, a medium-bodied silicone impression material (vinyl polysiloxane) was used to create a stent, which could be used intra-orally to build the tooth up in composite (Figure 5).

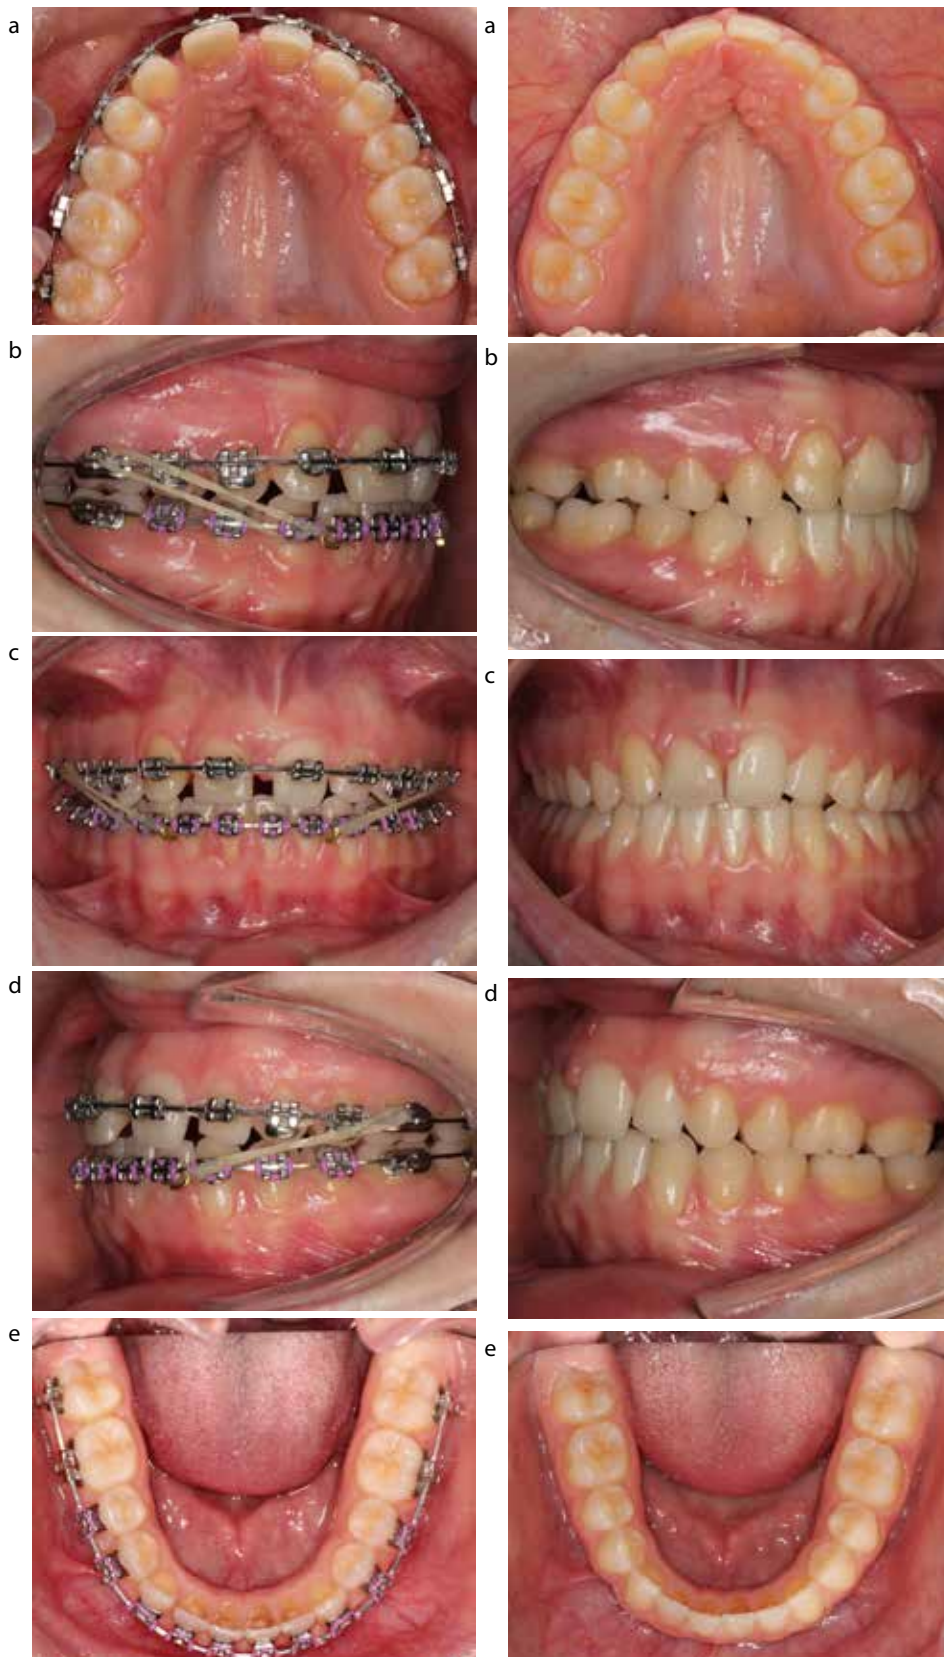
**Figure 7. (a–e)** 2/4/15. Class III elastics, power-chain on upper 19/25 stainless steel archwire.

Now that the UR2 was a size relative to the UL1, the remaining orthodontic treatment involved upper centreline correction and complete space closure in the upper arch. This was achieved by the use of a power chain on an upper 19/25 stainless steel archwire. To allow mesial movement of the upper buccal segments and prevent reduction of the overjet and overbite, the patient

was instructed to wear Class III elastics 24 hours a day. Final detailing and finishing was completed on round stainless steel archwires (Figure 7).

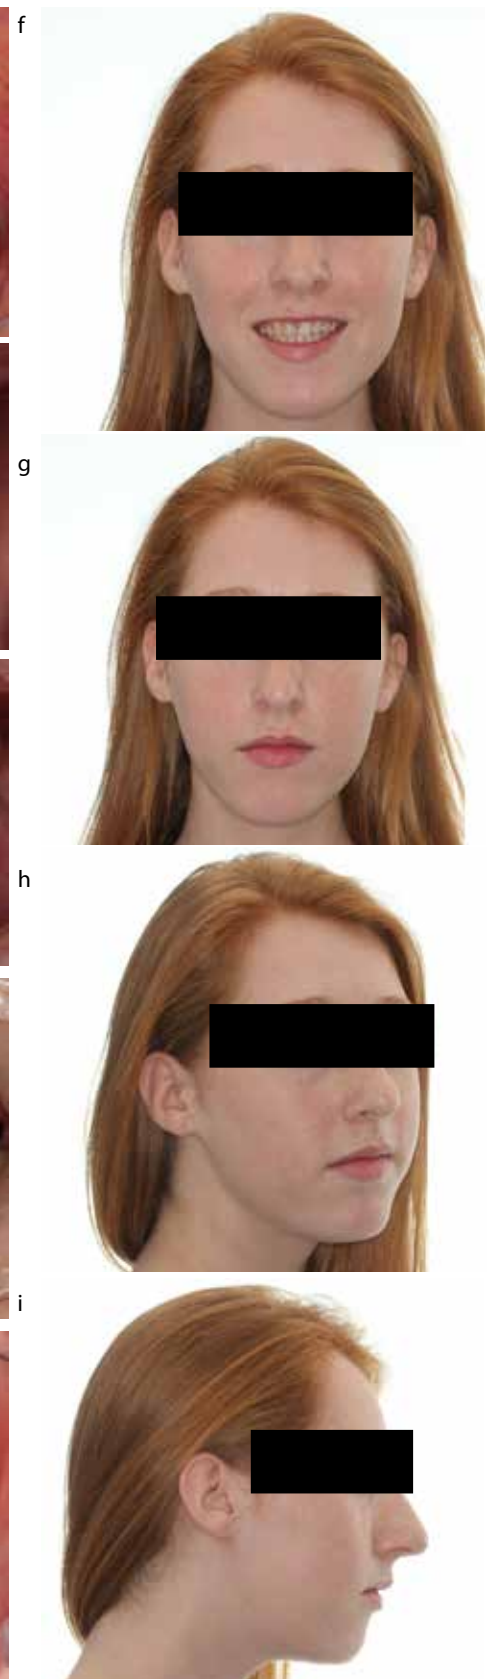
**Figure 8. (a–i)** 24/9/15. Debond and review.

The patient was debonded after 2 years of orthodontic treatment with the occlusion and facial appearance as in Figure 8.

From a critical perspective, the upper centreline is to the right by approximately 1.5 mm. This may have occurred due to the asymmetric arrangement and size of teeth in the upper left and right labial segments. Considering the overall result, it was felt that this was acceptable and unlikely to be noticed by members of the public.<sup>13</sup>
