Defective Dental Restorations: To Repair or Not to Repair? Part 2: All-Ceramics and Porcelain Fused to Metal Systems

Dent Update 2011; 38: 150–158

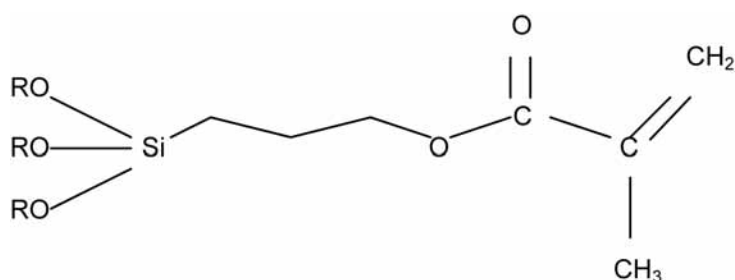
Figure 1. Chemical formula of a typical silane coupling agent (3-methacryloxypropyltrimethoxysilane).

Silane coupling agents are mediators that promote adhesion between inorganic and organic substances.⁵¹ They are characterized as molecules with two ends of different polarity; they are bifunctional and have dual reactivity: the hydrolyzable alkoxy groups of the silanol unit, (RO)₃Si group on the left side in Figure 1, form a chemical bond with the silicized surface. The methacrylate groups on the right side in Figure 1 copolymerize with the monomers of adhesive resins. This allows a chemical bond to be achieved between a ceramic surface and an applied resin. Silanes may also be viewed as materials that increase the surface energy of an acid-etched ceramic so that a hydrophobic composite resin can more easily penetrate into it.⁴⁶

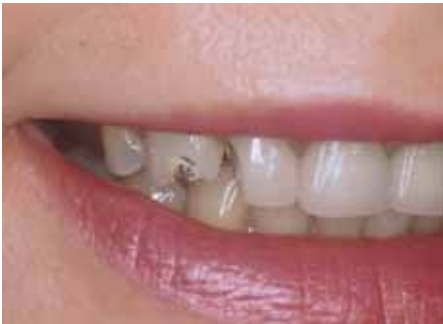
Figure 2. The loss of ceramic from the metal-ceramic crowns following trauma is evident (presented with kind permission of George Warman Publications).

A 35-year-old woman was referred because of loss of ceramic from two metal-ceramic crowns following trauma. Examination showed a complex fracture where porcelain had fractured from the labial surfaces of the patient's maxillary right lateral incisor and canine teeth (Figure 2). Clinical and radiographical examination indicated that the crown margins were sound, although some gingival recession was present. The patient stated that she was satisfied with the appearance of the crown margins as they were not visible on smiling and it was therefore decided to repair the crowns. The shade of the crowns was noted. The defective crowns were then isolated using rubber dam and the patient was provided with protective eyewear. The exposed metal was sandblasted using an intra-oral sandblaster (Microetcher: Danville Engineering) filled with CoJet sand at 40psi for 15 seconds, which had resulted in a matt appearance of the exposed metal surface (Figure 3). Silane (ESPE-SIL) was then applied to the treated metal surface and allowed to dry for 30 seconds. The

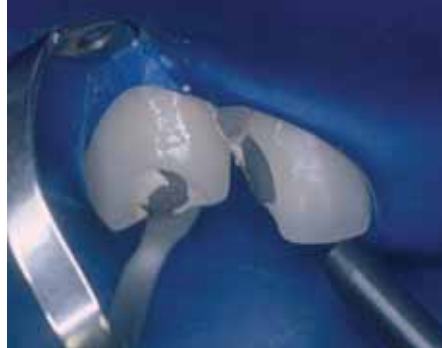
Figure 3. After treatment with CoJet powder from an intra-oral sandblaster the exposed metal has a matt appearance.

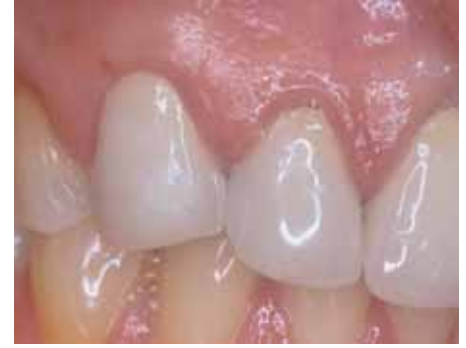
Figure 4. The repair was completed with the CoJet system and a composite resin restorative material (Filtek Z250; 3M ESPE).

powder and liquid of the opaquer (Visio Gem, 3M ESPE) were mixed and applied in a thin layer to the exposed metal and light cured for 10 seconds. A layer of unfilled resin (Visio Bond, 3M ESPE) was then applied to the opaquer and light cured for 20 seconds, following which the defect was repaired using a composite resin restorative material (Figure 4).

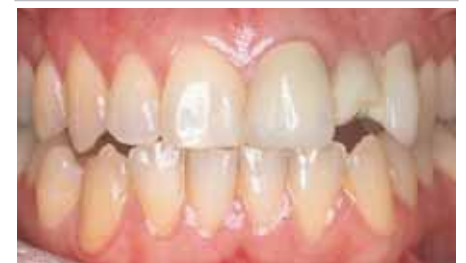
Figure 5. Ceramic had been lost from the metal-ceramic bridge pontic following trauma.

The patient, a 35-year-old female, attended following trauma to UL2, a metal-ceramic bridge pontic. The bridge was of adequate fit and appearance: it had not been loosened during the trauma. The ceramic at the incisal edge of the pontic had been fractured off (Figure 5), with a small amount of metal exposed (complex fracture). Although it was considered that a replacement bridge could be constructed with improved aesthetics, the patient requested that an attempt be made to repair the existing bridge and this was duly carried out under rubber dam isolation using the stages of the CoJet system (3M ESPE, Seefeld, Germany) and a composite resin restorative material; a substantially more minimally invasive option than a replacement bridge (Figure 6).

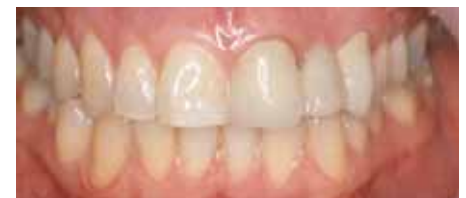
Figure 6. Completed repair of the bridge pontic in Figure 5 using the CoJet system and composite resin material (Filtek Z250; 3M ESPE).
